THE CLINICAL PICTURE

A second-degree burn after MRI

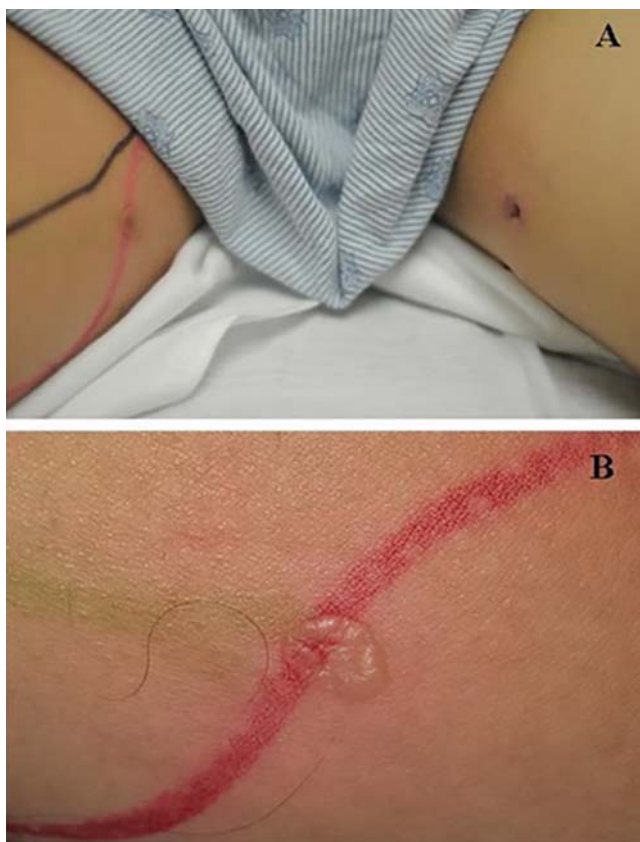
FIGURE 1. (A) Articulating 1-cm lesions developed after magnetic resonance imaging. The black and red tracings on the right inner thigh indicate the original area of cellulitis. (B) A bullous lesion with clear serous fluid on the right medial thigh.

After the procedure, the patient was noted to have a bullous lesion on each thigh, each lesion roughly 1 cm in diameter and filled with clear serous fluid (**Figure 1**). He reported that his legs had been pressed together before entering the MRI machine and that he had felt a burning sensation in both thighs during the test. Examination confirmed that the lesions indeed aligned with each other when he pressed his thighs together.

We believe that during placement in the scanner, our patient inadvertently moved his

thighs together, forming a closed loop conduction circuit and resulting in a thermal burn.

This case illustrates the importance of correct positioning during MRI. The MRI technicians had taken standard precautions, placing a sheet over the patient and ensuring no direct contact with the radio-frequency transmitter receiver (MR unit). However, precautions against skin-to-skin contact were not taken, and the patient's legs were not separated.

Appropriate positioning prevents closed skin-to-skin loops, but this may be more challenging in a larger patient.⁶ While the patient is in the scanner, a “squeeze ball” alert system allows the patient to signal the technologist should unexpected distress or heating occur.^{6,7} A patient's inability to utilize the squeeze ball contributes to the risk of a severe injury. Further, in this instance, there may have been a language barrier. Also, proximity of the anatomic skin-to-skin loop to the imaged body part (and therefore the center of the MRI coil) may have conferred risk related to field strength in this patient.

The MRI technologist, under supervision of a radiologist, is primarily responsible for positioning the patient to decrease the risk of this complication and for following institutional MRI safety protocols and professional guidelines.^{6–8} MRI technologist certification training highlights all aspects of safety, including skin-to-skin conducting loop prevention.^{7,8}

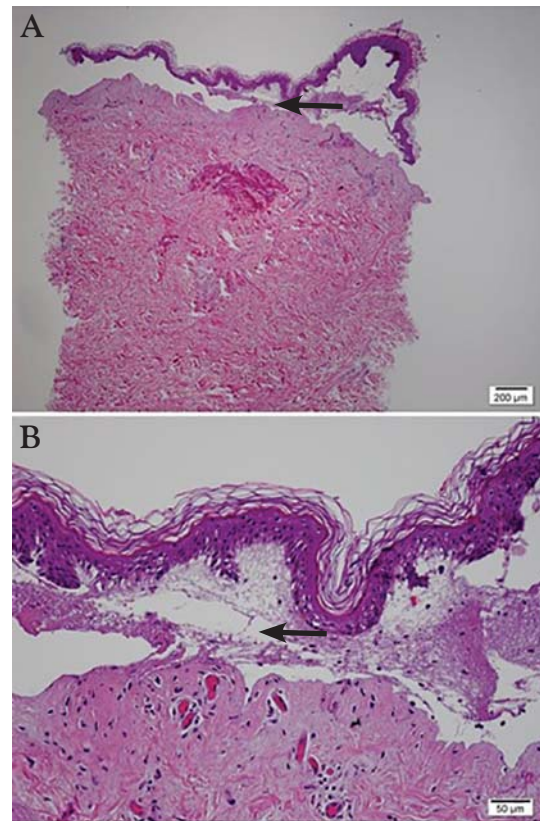
Study of a biopsy of one of the lesions revealed subepidermal cell blisters with focal epidermal necrosis and coagulative changes in the superficial dermis, consistent with a thermal injury (**Figure 2**).

FIGURE 2. Focal epidermal necrosis (arrows) and coagulative changes in the superficial dermis were consistent with thermal injury (hematoxylin and eosin; panel A magnification $\times 2.5$; panel B magnification $\times 10$).
