THE CLINICAL PICTURE

A second-degree burn after MRI

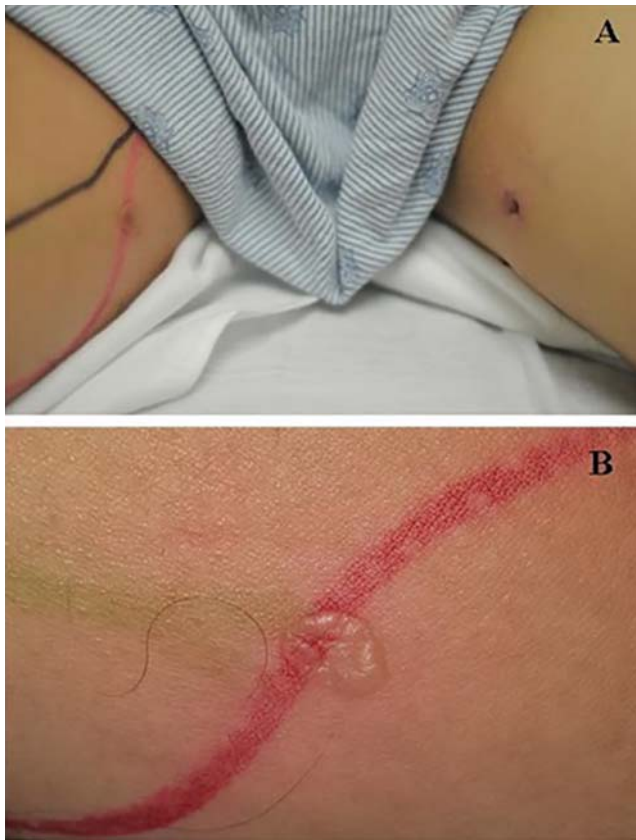
FIGURE 1. (A) Articulating 1-cm lesions developed after magnetic resonance imaging. The black and red tracings on the right inner thigh indicate the original area of cellulitis. (B) A bullous lesion with clear serous fluid on the right medial thigh.

After the procedure, the patient was noted to have a bullous lesion on each thigh, each lesion roughly 1 cm in diameter and filled with clear serous fluid (**Figure 1**). He reported that his legs had been pressed together before entering the MRI machine and that he had felt a burning sensation in both thighs during the test. Examination confirmed that the lesions indeed aligned with each other when he pressed his thighs together.

thighs together, forming a closed loop conduction circuit and resulting in a thermal burn.

This case illustrates the importance of correct positioning during MRI. The MRI technicians had taken standard precautions, placing a sheet over the patient and ensuring no direct contact with the radio-frequency transmitter receiver (MR unit). However, precautions against skin-to-skin contact were not taken, and the patient's legs were not separated.

Appropriate positioning prevents closed skin-to-skin loops, but this may be more challenging in a larger patient.⁶ While the patient is in the scanner, a “squeeze ball” alert system allows the patient to signal the technologist should unexpected distress or heating occur.^{6,7} A patient's inability to utilize the squeeze ball contributes to the risk of a severe injury. Further, in this instance, there may have been a language barrier. Also, proximity of the anatomic skin-to-skin loop to the imaged body part (and therefore the center of the MRI coil) may have conferred risk related to field strength in this patient.

The MRI technologist, under supervision of a radiologist, is primarily responsible for positioning the patient to decrease the risk of this complication and for following institutional MRI safety protocols and professional guidelines.^{6–8} MRI technologist certification training highlights all aspects of safety, including skin-to-skin conducting loop prevention.^{7,8}

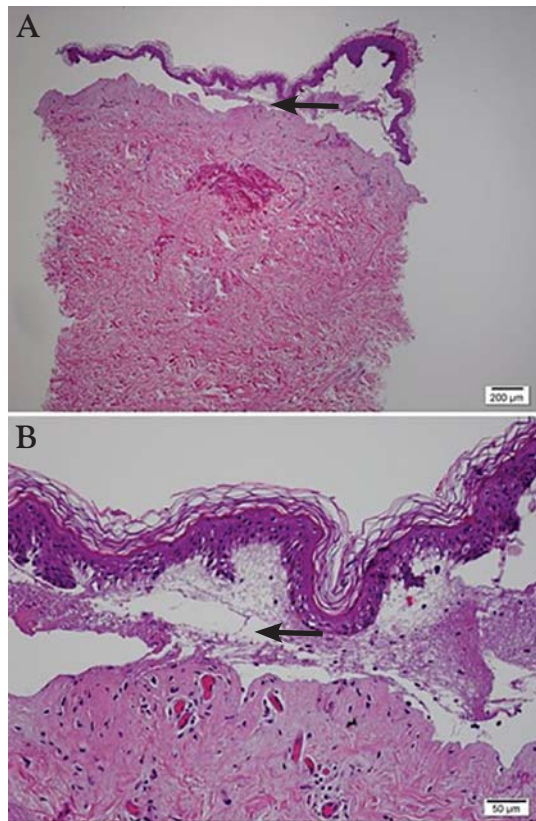
Study of a biopsy of one of the lesions revealed subepidermal cell blisters with focal epidermal necrosis and coagulative changes in the superficial dermis, consistent with a thermal injury (**Figure 2**).

FIGURE 2. Focal epidermal necrosis (arrows) and coagulative changes in the superficial dermis were consistent with thermal injury (hematoxylin and eosin; panel A magnification $\times 2.5$; panel B magnification $\times 10$).
